ERS Remediates Gas Skid Units at New England Power Plant

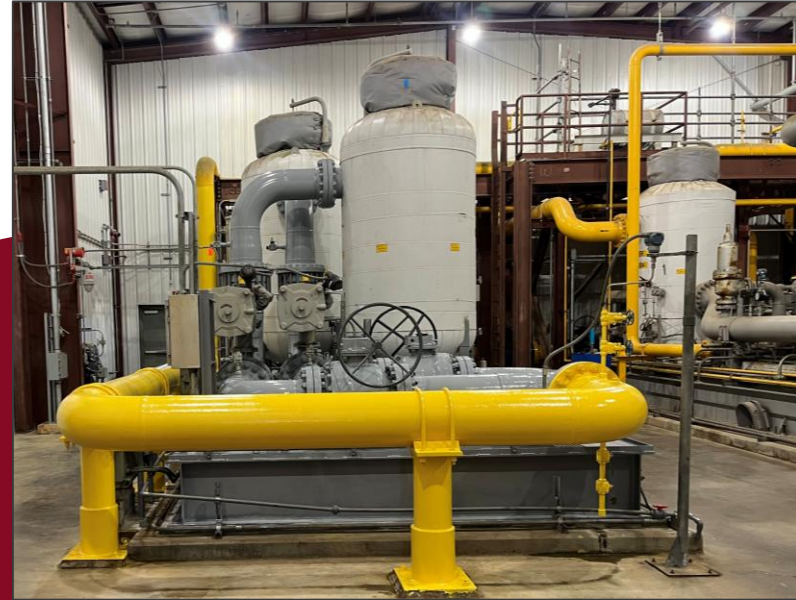
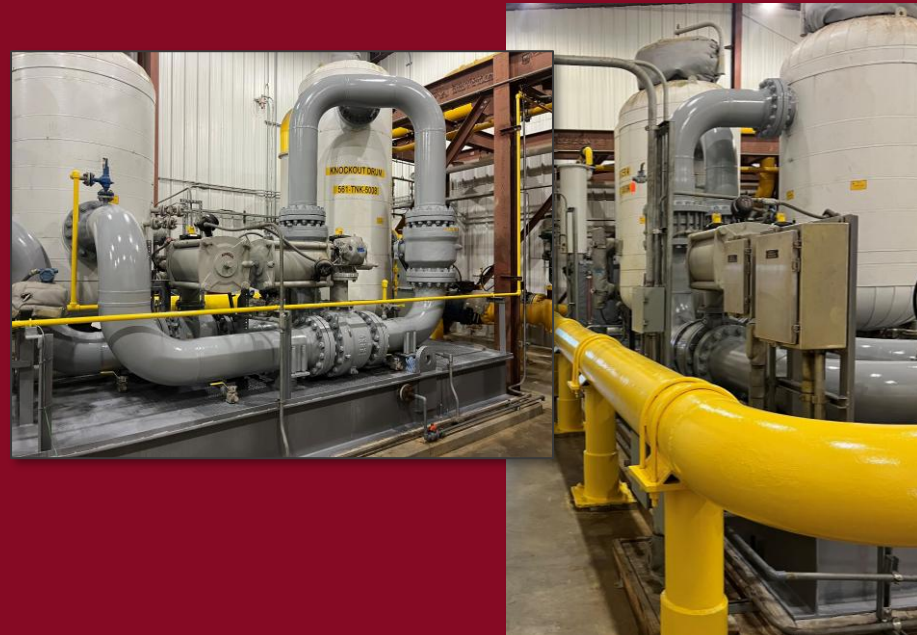
- ✓ *A New-England power plant experienced repeated wet/dry cycles that deteriorated coating on piping and skids*
- ✓ *Extreme peeling, blistering, and rusting of piping and skid area were difficult to address due to hard to reach areas*

- ✓ *ERS prepared and coated piping with a Macropoxy and Hi Solids Epoxy system*
- ✓ *ERS prepared and coated skid with ERS 80RS Rust Stopper for a long-term rust and degradation remediation*
